DEPARTMENT OF TRANSPORTATION**DIVISION OF ENGINEERING SERVICES**

Quality Assurance and Source Inspection

Contract #: 04-0120F4Cty: SF/ALA Rte: 80 PM: 13.2/13.9File #: 1.28**WELDING INSPECTION REPORT****Resident Engineer:** Casey, William**Address:** 333 Burma Road**City:** Oakland, CA 94607**Report No:** WIR-027753**Date Inspected:** 11-Jun-2012**Project Name:** SAS Superstructure**OSM Arrival Time:** 700**Prime Contractor:** American Bridge/Fluor Enterprises, a JV**OSM Departure Time:** 1930**Contractor:** American Bridge/Fluor Enterprises, a JV**Location:** Job site**CWI Name:** As Noted Below**CWI Present:** Yes No**Inspected CWI report:** Yes No N/A**Rod Oven in Use:** Yes No N/A**Electrode to specification:** Yes No N/A**Weld Procedures Followed:** Yes No N/A**Qualified Welders:** Yes No N/A**Verified Joint Fit-up:** Yes No N/A**Approved Drawings:** Yes No N/A**Approved WPS:** Yes No N/A**Delayed / Cancelled:** Yes No N/A**Bridge No:** 34-0006**Component:** OBG/Tower**Summary of Items Observed:**

OBG (13E Deck drop-in)

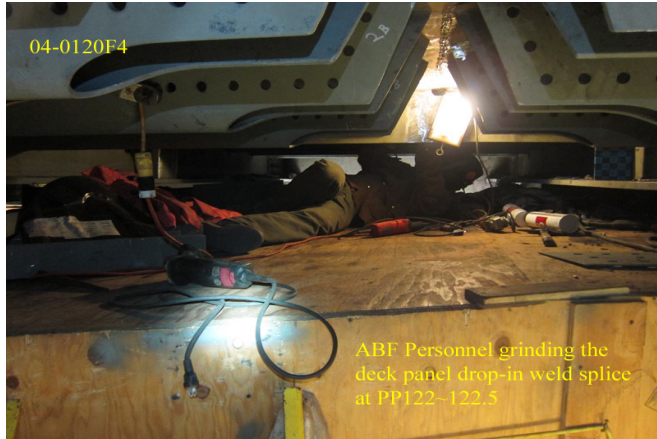
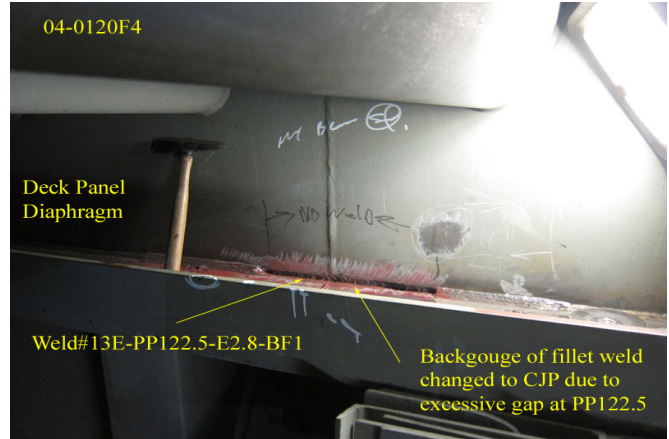
This QA observed ABF/JV welding personnel performing back gouging of weld 13E-PP122.5-E2.8-BF1. Due to an excessive gap the designed fillet was changed to a Complete Joint Penetration (CJP) with the approval of the engineer for a total of 260mm. The Quality Control (QC) Inspector Salvador Merino performed Magnetic Particle (MT) and visual confirmation of the excavation after it was ground to a bright finish. No indications observed to be present at the time of inspection.

The QA inspector observed ABF/JV qualified welder Steve Davis #7889 performing Shielded Metal Arc Welding (SMAW) in the 2G position implementing Caltrans approved Welding Procedure Specification (WPS) ABF-WPS-D1.5-1100. The joint being welded was the floor beam web to the floor beam flange splice at panel point 122.5 and is designated as 13E-PP122.5-E2.8-BF1. The repair surface and surrounding area was brought to temperature the use of a gas torch and the preheat temperature was confirmed by ABF personnel prior to welding. The Quality Control (QC) inspector Salvador Merino was noted monitoring the welding parameters at the beginning of the shift. The welding at this location was completed prior to the end of the QA inspectors shift.

The QA inspector observed at random intervals ABF/JV qualified welder Richard Garcia #5892 performing Shielded Metal Arc Welding (SMAW) in the 3G position utilizing the Caltrans approved Welding Procedure (WPS) ABF-WPS-D1.5-1012-3. The welding observed was for the repair of the HPS485 longitudinal deck stiffener weld splice designated as LS13E/14E LS 7 and LS13E/14E LS 8. The repair surface and surrounding area was brought to temperature by the use of a gas torch and the preheat temperature was confirmed to be greater than 200°F by ABF personnel prior to welding. The repair welding was observed to be completed prior to the end of the QA inspectors shift.

The QA inspector periodically observed ABF/JV qualified welder Steve Davis #7889 performing Shielded Metal Arc Welding (SMAW) in the 3G position utilizing the Caltrans approved Welding Procedure Specification ABF-WPS-D1.5-1030. The welding observed was for the deck panel diaphragm web splice at panel point 122.5. The repair surface and surrounding area was brought to temperature by the use of a gas torch and the preheat temperature was confirmed ABF personnel prior to welding. The Quality Control (QC) inspector William Sherwood was observed monitoring the welding parameters at the beginning of the shift. The weld was completed from face "A" only during the QA inspectors shift and will require back gouging and final welding at a later date.

The QA inspector observed at random intervals ABF/JV qualified welder Richard Garcia #5892 performing Shielded Metal Arc Welding (SMAW) in the 1G position utilizing the Caltrans approved Welding Procedure Specification ABF-WPS-D1.5-1040A. The weld is a Complete Joint Penetration splice between the horizontal floor beam flanges at panel point floor 123 and is designated as 13E-PP123-E2.1-BF2 beam repair surface and surrounding area was brought to temperature by the use of a gas torch and the preheat temperature was confirmed by ABF personnel prior to welding. The welding at this location was observed to be completed prior to the end of the QA inspectors shift.
